Report on
Stage 1 (Preliminary) Site Investigation for
Contamination

Proposed Childhood Early Learning Centre
Part of 2 High Valley Close and 689 The Entrance
Road, Wamberal

Project 83717.00
December 2019

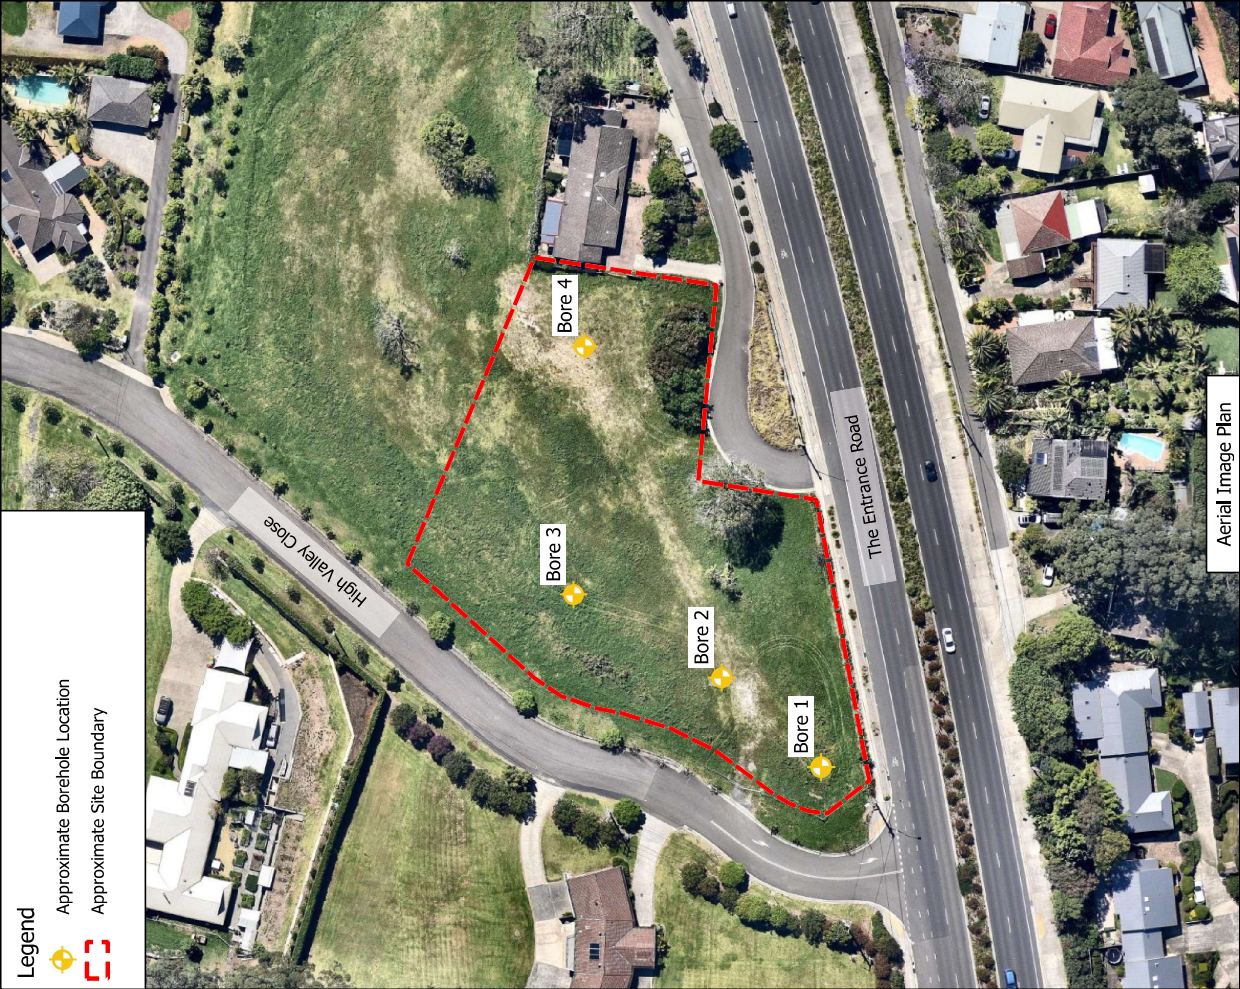
Douglas Partners Geotechnics Environment Groundwater			Test Location Plan

- o WorkCover records indicated:
 - 1971: An application was lodged for a UST which was located north of the house which was visible in 1964 and 1974 aerial photographs (It is noted that this location would approximately correlate with Bore 4 in Drawing 1);

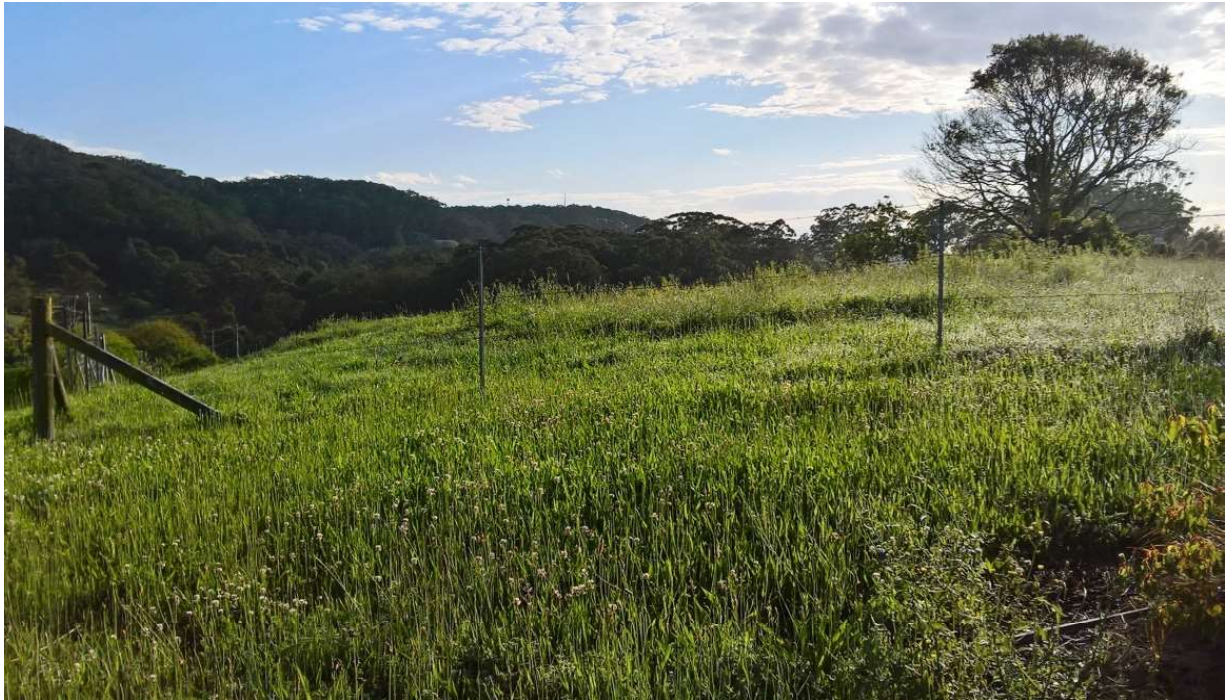
Photo 1 - South-western corner of the site, looking toward the north-west, 15 October 2019.

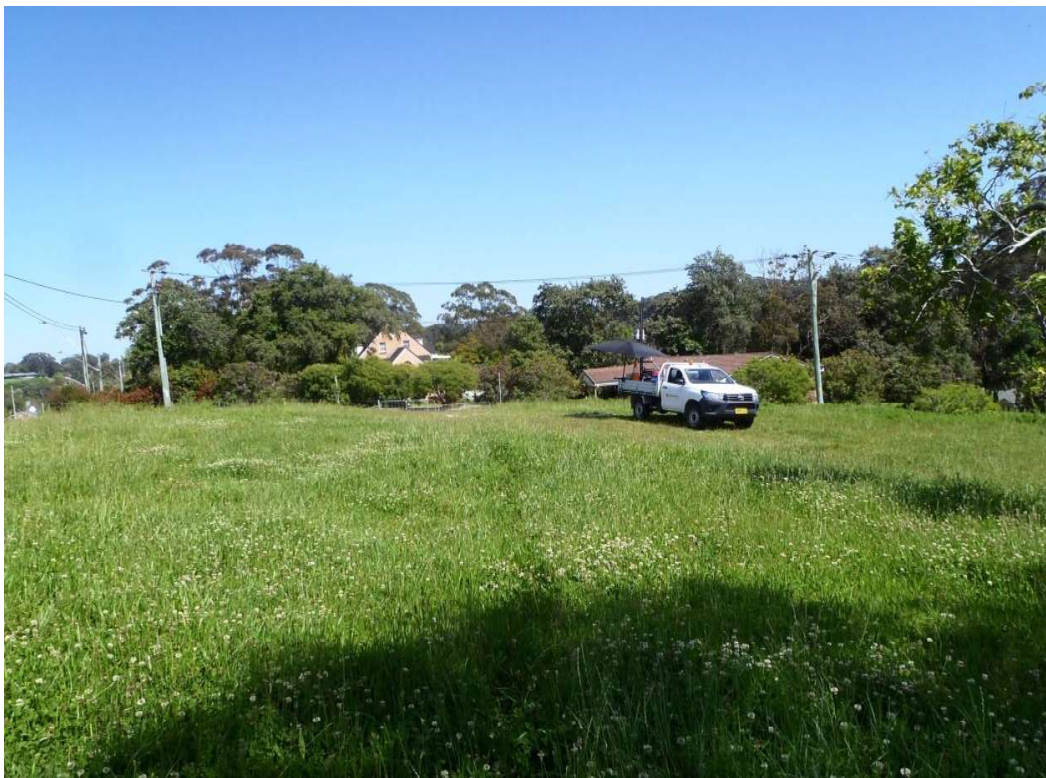
The site sloped down steeply toward the north-east. Several mounds or possible vegetated stockpiles were noted at the southern end of the site and some concrete fragments were noted at the surface.

Photo 2 - Middle of the site, looking toward the north-west, 15 October 2019.

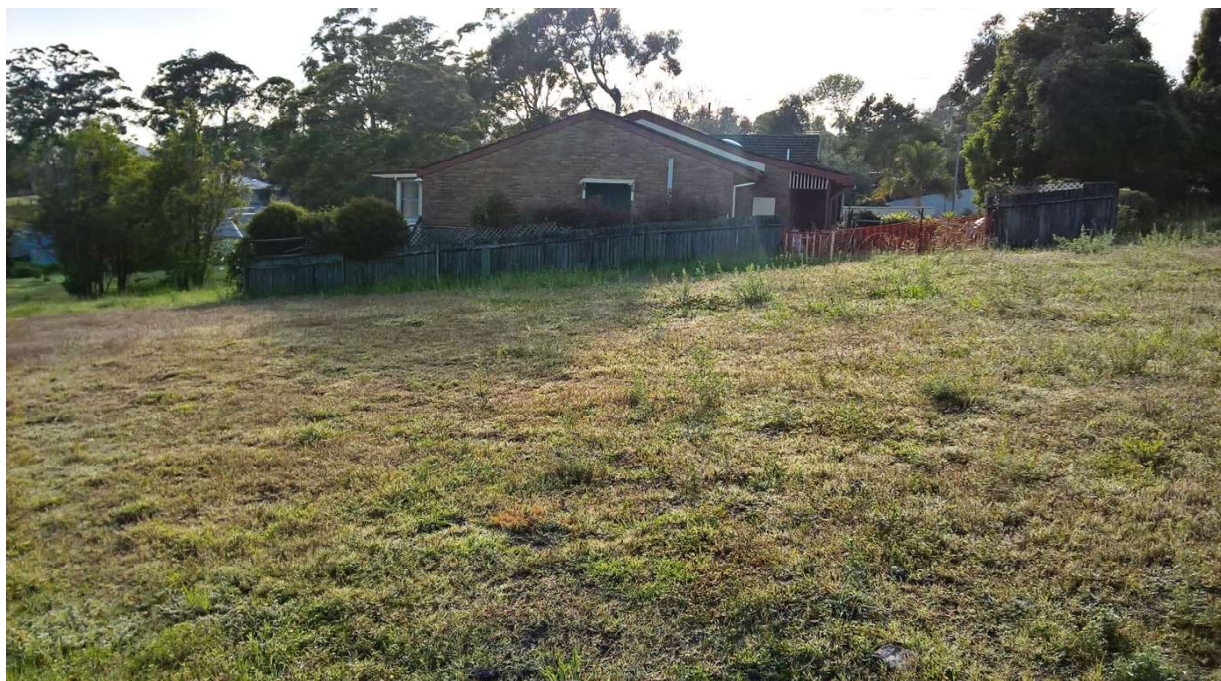
The site and surrounding area appear generally similar to the May 2010 photograph, although the sheds noted at the south-eastern end of the site appear to have been removed / demolished. The duplex noted in the site walkover (see Section 6) appears to the east of the site boundary.

Photo 3 - Neighbouring Duplex, looking toward the east, 15 October 2019.

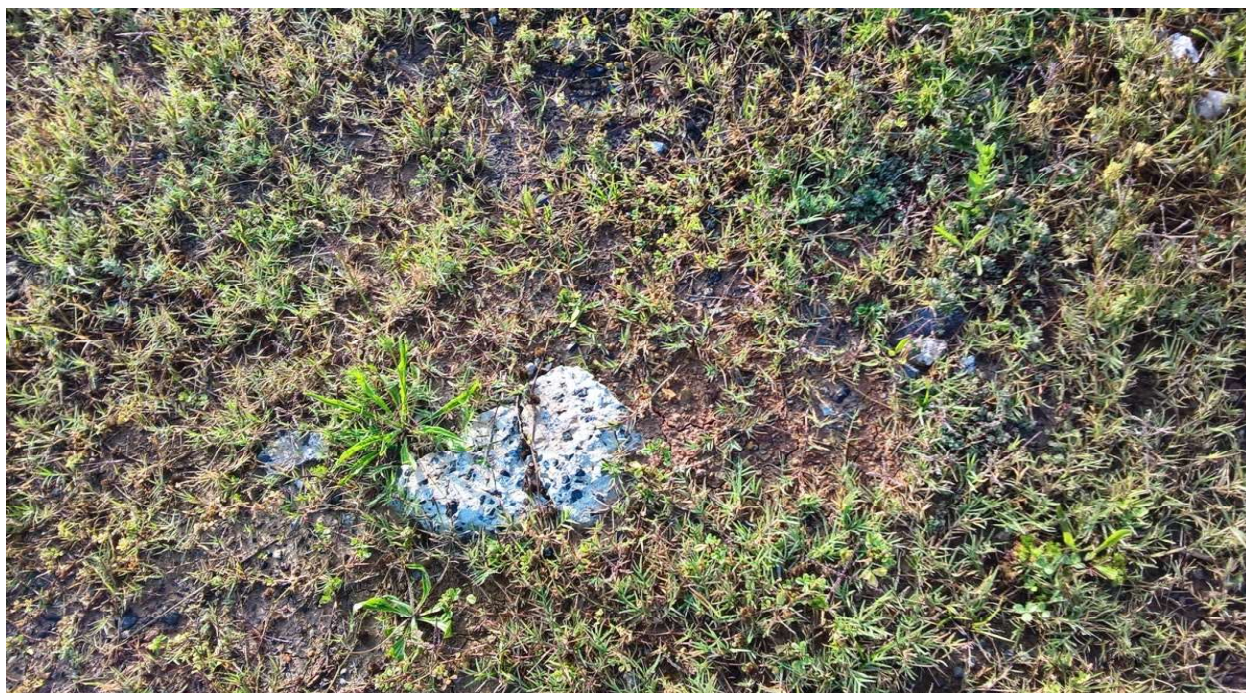
Other than the concrete, asphalt and plastic encountered in fill and the concrete fragments found on the site's surface during the walkover (Section 6), no other anthropogenic materials were found at the site.

Photo 4 - Typical of the concrete fragments noted at the surface, 15 October 2019.
